FAMA BUYER'S GUIDE

TC043

Retroreflective Striping and Chevron

Prepared by the FAMA Body Subcommittee

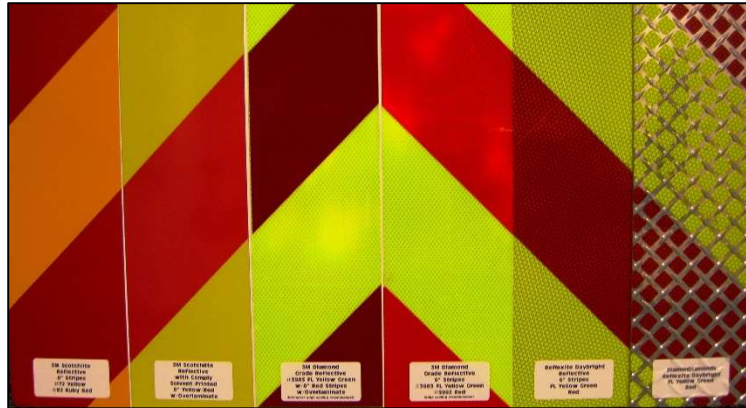
NFPA 1901 also is specific in the colors of the rear chevron material. The image below shows the NFPA approved colors.

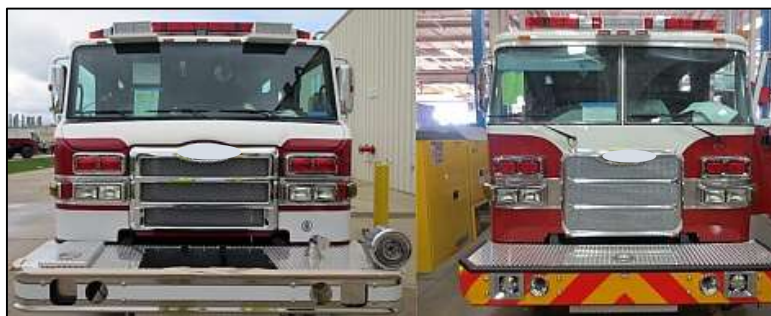
FRONT OF VEHICLE

A minimum of a 4.00 in. stripe that covers at least 25% of the width of the front of the apparatus. The stripe may be interrupted by vehicle installed items.

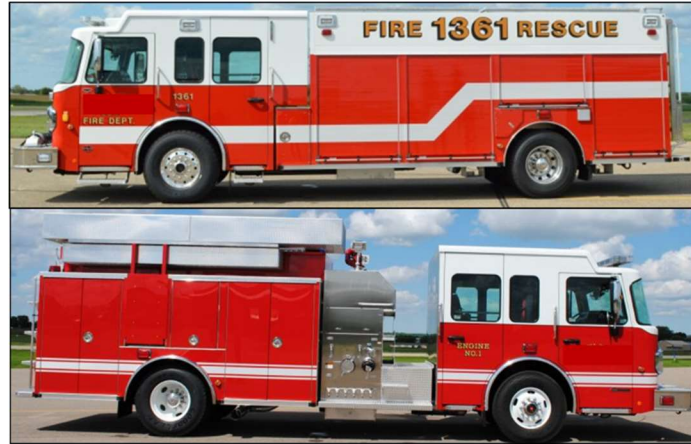
VEHICLE SIDES

A minimum of a 4.00 in. stripe that covers at least 50% of the side of the cab and body on each side excluding the pump panel area. The stripe may be interrupted by vehicle installed items.

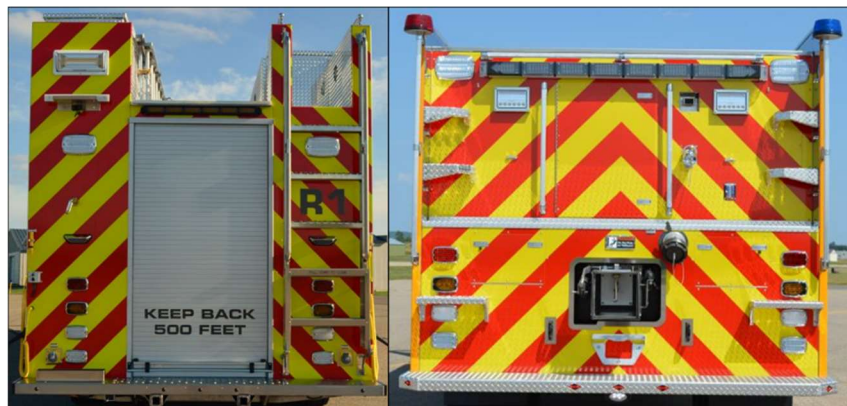
REAR OF VEHICLE

At least 50% of the rear facing vertical surfaces covered in a chevron pattern with alternating 6.00 in. red and 6.00 in. approved yellow stripe sloping downward and away from the centerline of the vehicle at a 45 degree angle.

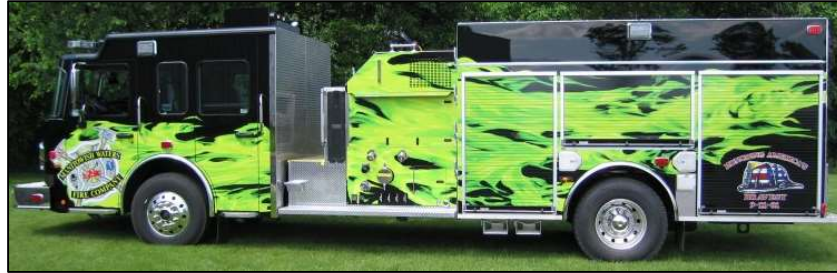
GRAPHIC DESIGNS

A retroreflective graphic design is allowed to replace all or part of the front and side striping requirements as long as it meets the coverage requirements of the front and side areas.

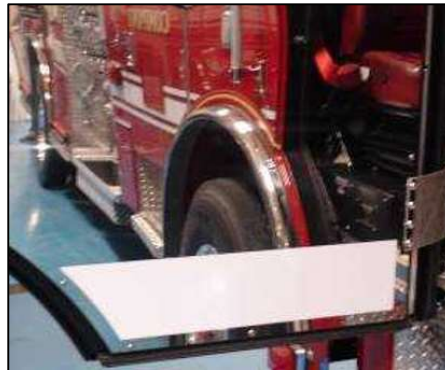
CREW ENTRY DOORS

Any entry door in the cab or body should have at least 96 square inches of retroreflective material installed on the inside of the door that will be visible to traffic from the rear.

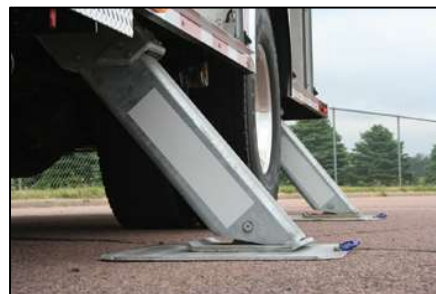
AERIAL DEVICES

Where the design of an aerial device incorporates a knuckle it should be painted with a reflective paint or provided with retroreflective tape.

All vehicle stabilizers that protrude outside of the body should be provided with retroreflective material to indicate a hazard.
