## FAMA BUYER'S GUIDE

### TC043

# Retroreflective Striping and Chevron

Prepared by the FAMA Body Subcommittee

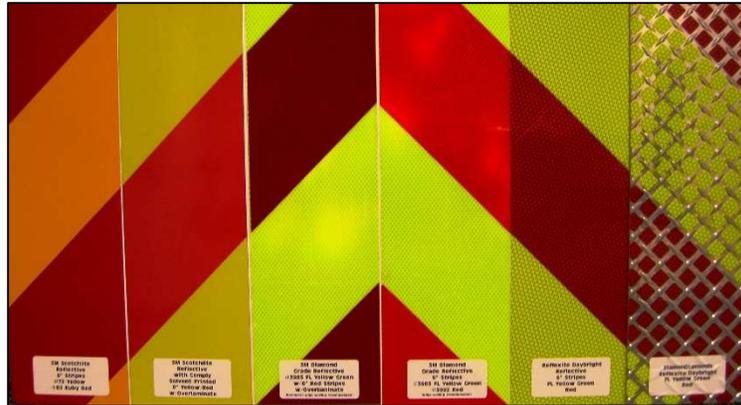
NFPA 1901 also is specific in the colors of the rear chevron material. The image below shows the NFPA approved colors.

End users may want to change the chevron colors to compliment the color scheme of their vehicle. The apparatus manufacturer will ask that a Statement of Exception (waiver) to the NFPA guideline is signed by a responsible party if chevron stripe colors, other than the NFPA approved colors, are applied to the vehicle.

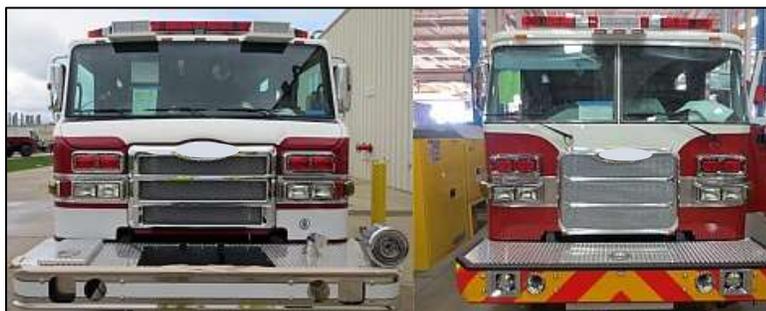
### FRONT OF VEHICLE

A minimum of a 4.00 in. stripe that covers at least 25% of the width of the front of the apparatus. The stripe may be interrupted by vehicle installed items.

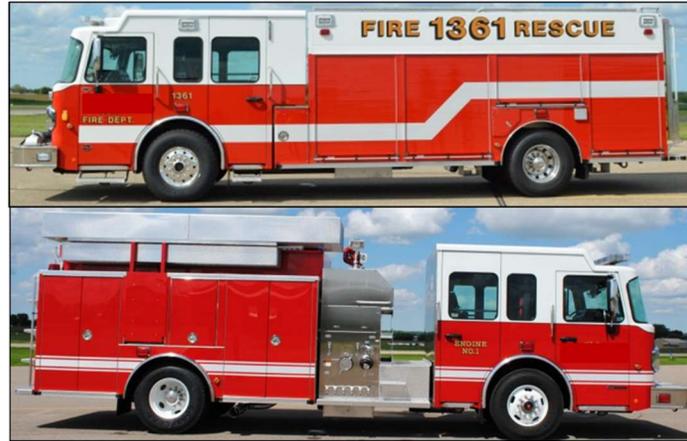
### VEHICLE SIDES

A minimum of a 4.00 in. stripe that covers at least 50% of the side of the cab and body on each side excluding the pump panel area. The stripe may be interrupted by vehicle installed items.

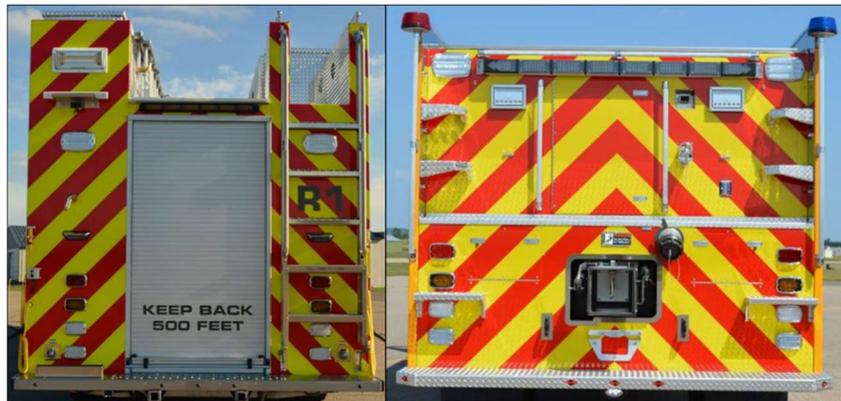
### REAR OF VEHICLE

At least 50% of the rear facing vertical surfaces covered in a chevron pattern with alternating 6.00 in. red and 6.00 in. approved yellow stripe sloping downward and away from the centerline of the vehicle at a 45 degree angle.

The guidelines for NFPA 1906 are the same as NFPA 1901 with the exception that the coverage at the rear of the vehicle does not have to be in a chevron pattern and may be one color.

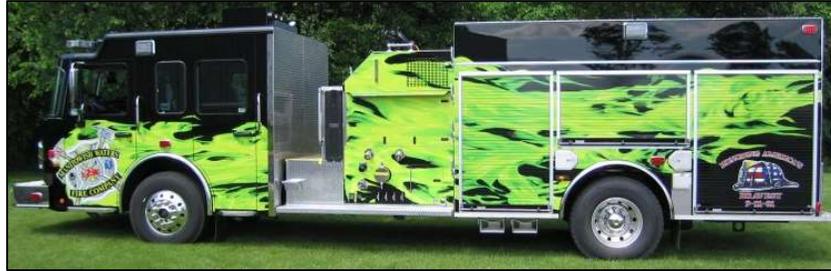
### GRAPHIC DESIGNS

A retroreflective graphic design is allowed to replace all or part of the front and side striping requirements as long as it meets the coverage requirements of the front and side areas.

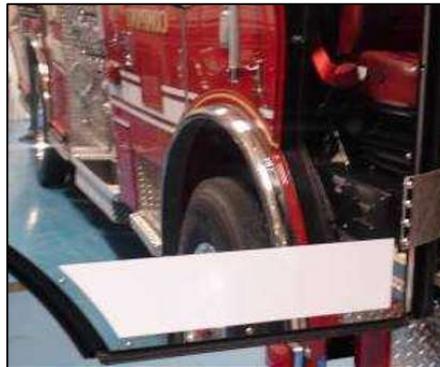
### CREW ENTRY DOORS

Any entry door in the cab or body should have at least 96 square inches of retroreflective material installed on the inside of the door that will be visible to traffic from the rear.

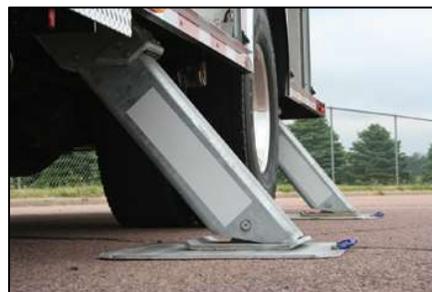
### AERIAL DEVICES

Where the design of an aerial device incorporates a knuckle it should be painted with a reflective paint or provided with retroreflective tape.

All vehicle stabilizers that protrude outside of the body should be provided with retroreflective material to indicate a hazard.
